Operation of the RCNP Cyclotron

K. Hatanaka, M. Fukuda, T. Yorita, T. Saito, H. Tamura, M. Kibayashi, Y. Inata^a, H. Gotoh^a,
H. Yana^a, Y. Ohe^a, K. Masuda^a, K. Yadommi^a, M. Rikiishi^a, T. Hata^a and K. Sadano^a
Research Center for Nuclear Physics (RCNP), Osaka University, Ibaraki, Osaka 567-0047, Japan
^a*Sumiju Accelerator Service (SAS)*

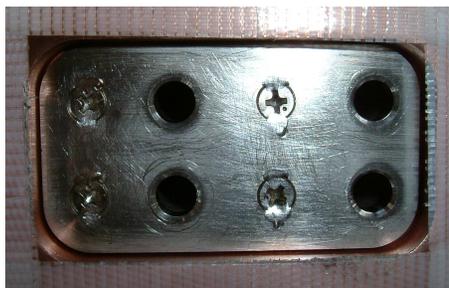
On January 18, there happened a water leak in the No. 2 RF cavity of the Ring cyclotron. It was a cooling channel of the upper tuning panel. The panel was disassembled and we found that a weld was eroded by a high-pressure water after a long time operation since the construction. The beam accelerator was resumed on February 16 after a temporary repair. During the summer maintenance period, both the upper and lower panels of three cavities were disassembled and all the welds were covered by stainless steel plates, see Fig. 1.

Figure 1: Stainless steel plate covering welds.
