Incident Cases:

Dosimeters detected radiation exposure although the workers were not working in a radiation exposure task

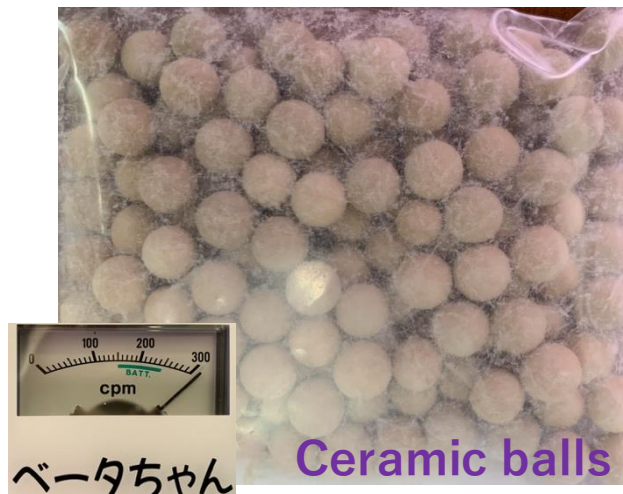
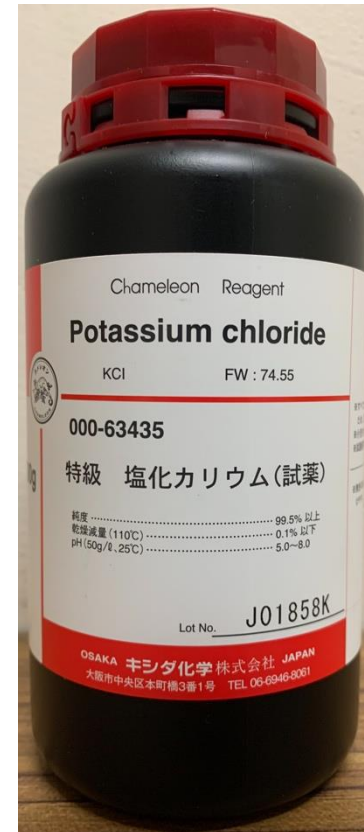
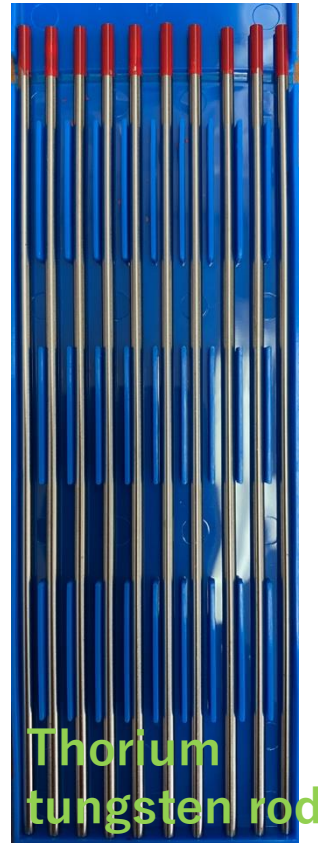
Case 1 :

The dosimeter was found stored together with natural radiation sources: a thorium tungsten rod, potassium chloride, a thorium-added mantle, and radium ceramic balls.

- If the administrator has designated a storage location for dosimeters, **store them in the designated location.**
- Do not place natural radiation sources near desks or other personal items.
- Areas where the **dose rate increases** during the use of irradiation equipment or accelerators must not be designated as storage locations for dosimeters.
- If possible, measure the dose rate at the storage location before storing the dosimeter.

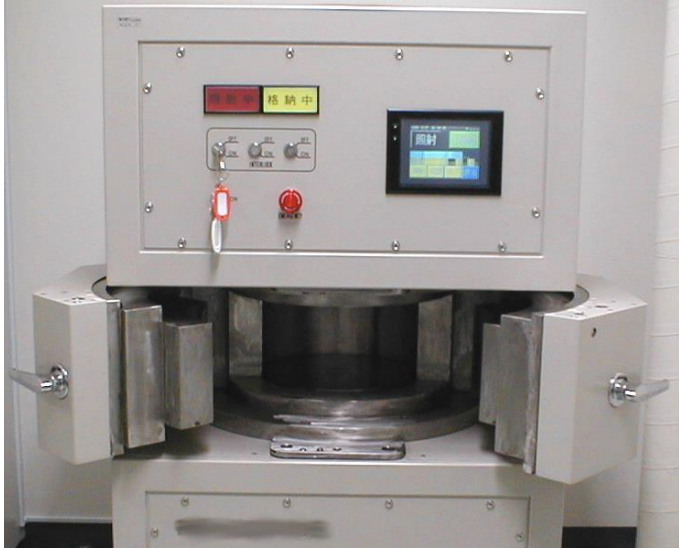
Case 2 :

On the floor below the room where the dosimeter was stored, a gamma radiation irradiation device had failed, the shutter would not close completely, and radiation was leaking into the office on the upper floor.

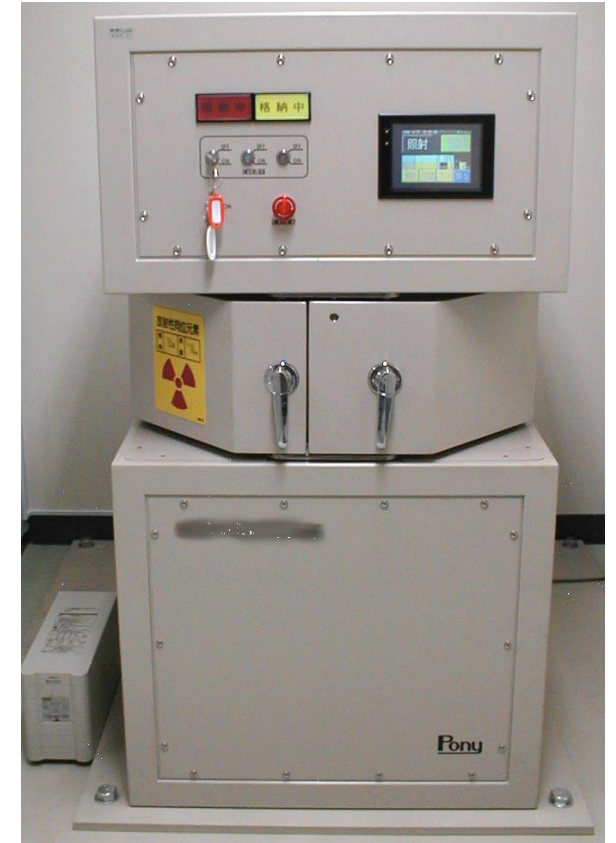
※ With some irradiation devices, even when the radiation source is stored, radiation is leaked at a level detectable by a survey meter when the door is open like this.

※ Some devices are designed with a leakage dose rate of $2 \mu\text{Sv/h}$ or less at the device surface.
